**ENVIRONMENTAL TEST PROGRAM
FOR ARIEL I**

by Warner H. Hord, Jr.

*Goddard Space Flight Center
Greenbelt, Maryland*

The environmental test program for Ariel I, the International Ionosphere Satellite, was accomplished at the Goddard Space Flight Center between April 27, 1961, and March 13, 1962. This program consisted of design qualification tests for the prototype spacecraft and acceptance tests for the two flight spacecraft. The spacecraft separation system and the flight vibration experiment also received design qualification and flight acceptance tests.

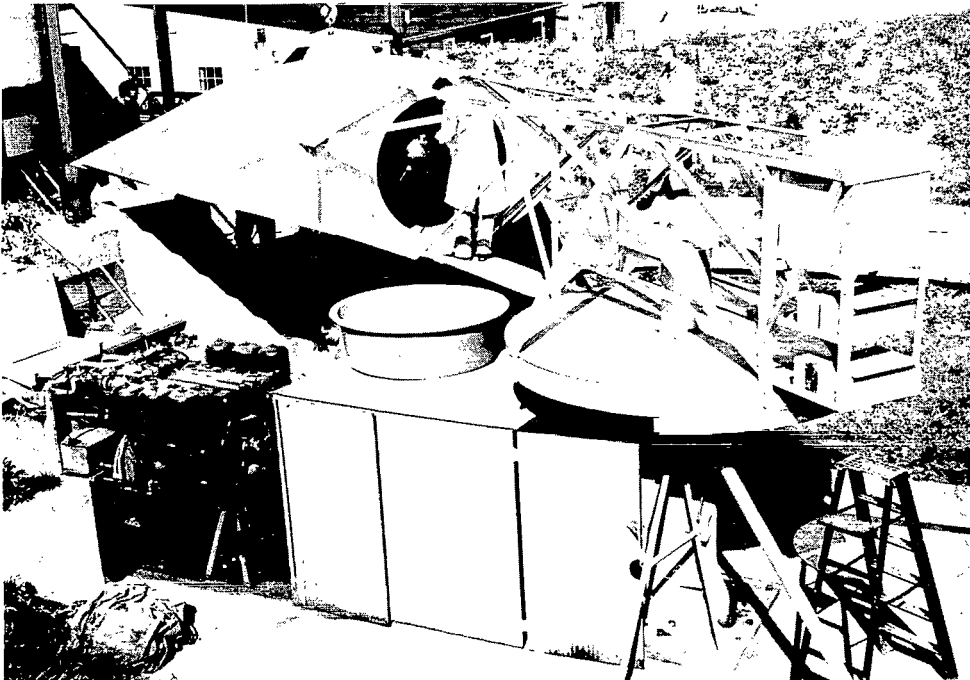
Figure 3—Prototype spacecraft installed on centrifuge for acceleration.

The maximum acceleration (18g), imparted to the Ariel I spacecraft by the Delta launch vehicle, occurs just prior to third-stage burnout. The orientation of the spacecraft on the centrifuge was selected so as to simulate the sustained loading of this thrust-induced acceleration. In addition, transverse acceleration tests were specified based on expected handling loads of 2g. Figures 2 and 3 show the prototype before and after installation on the centrifuge.
